Jagersfontein Tailings Dam Wall Collapse causes Fatalities, Injuries, Extensive Property Damage and leaves many homeless

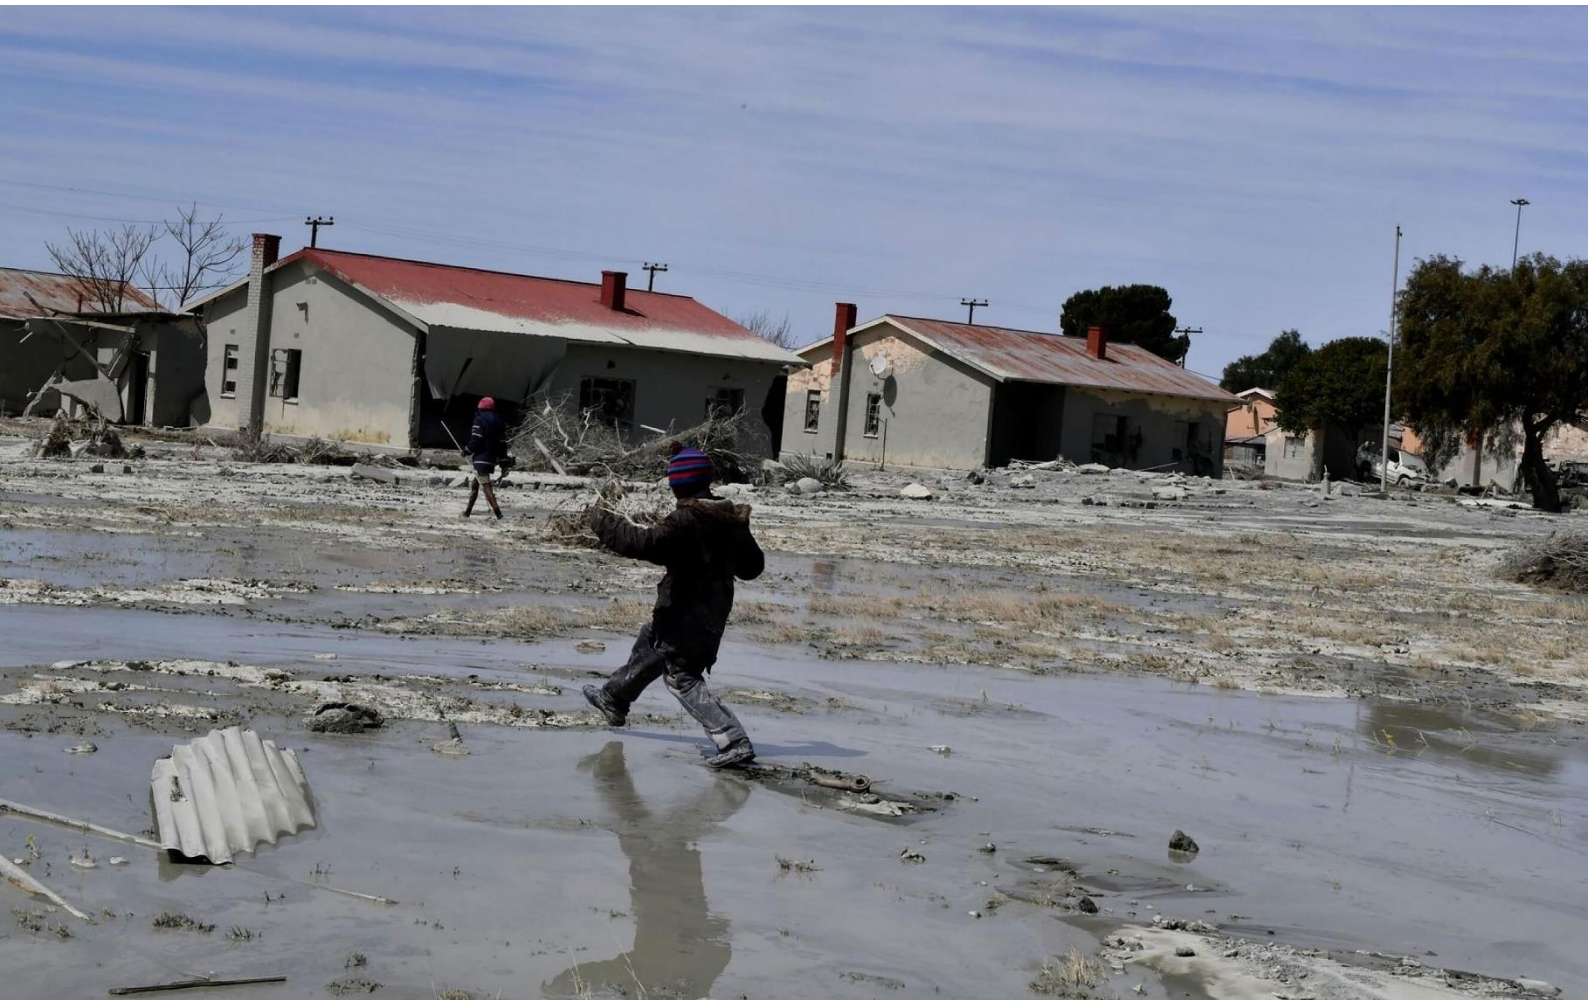
On Sunday, 11 September 2022, the community of Jagersfontein, a small town located approximately 100km from Bloemfontein in the Free State Province, was severely traumatized after the dam wall of a mothballed diamond mine, collapsed, killing 3 persons, injuring more than 40 and causing major damages to many houses and loss of livestock. The damage

caused by the collapsed dam's water and mud also caused damage to the town's electrical power. The diamond mine has been out of operation since 1970 and was recently sold to a UAE based owner.
